4. TITLE (and Subtitle) National Program of Inspection of Non-Federal Dams, Tennessee. Coon Creek Dam (Inventory Number TN 04508) near Lenox, Tennessee, Dyer County, TN., Obion River Basin.		5. TYPE OF REPORT & PERIOD COVERED Phase I Investigation Report

This report is based on the findings of the Phase I investigation of OFDBA Site #60-6 on February 4, 1981. This study was done in accordance with "Recommended Guidelines for Safety Inspection of Dams", Office of the Chief of Engineers.

The earth dam is 54 feet high and 726 feet long with a crest width of 25 feet. At normal pool the dam impounds a 125 acre lake (2137 acre-feet) used for flood control. It is in the intermediate size and high hazard potential category. The downstream slope is 2.6H:1V and the upstream slope is 3H:1V.

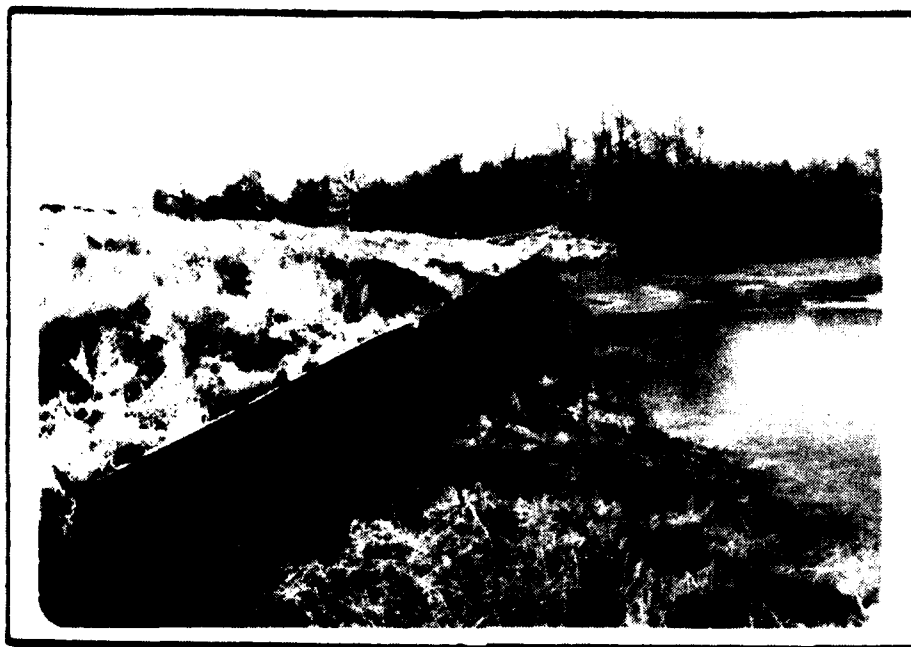
PHOTO NO. 1

Above the water level, the upstream slope is 3H:1V. According to design drawings, there is a 10 foot wide berm on the upstream slope at elevation 360. The berm was reportedly added to increase the safety factor against circular arc failure. At normal pool level, a wooden breakwater fence constructed of 2" x 12" treated boards is provided to decrease erosion from wave action (photo no. 1).

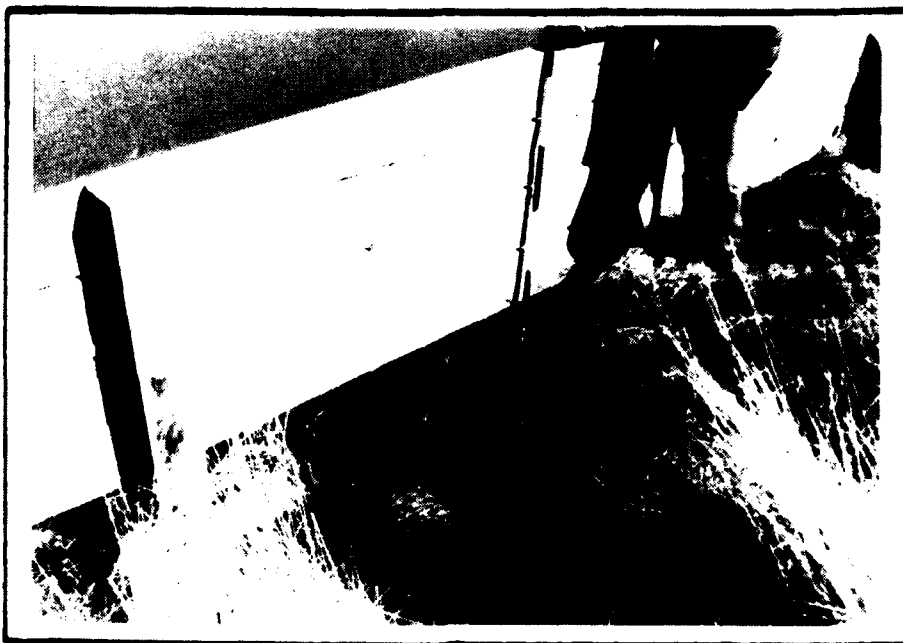
PHOTO NO. 2

3.1.1 Embankment - The downstream slope is 2.6H:1V with a 15 foot berm at elevation 374.9 and a 17 foot berm at elevation 361.3 (photo no. 5). The crest and slopes are uniform and showed no cracks, unusual settlement, or other signs of slope instability. Numerous gullies were observed on the upstream slope, most about 4 feet above normal pool level. These gullies were up to 4 or 5 feet deep (photo no. 4). Grass cover in this area is a well established fescue. There was also significant erosion at the base of the breakwater fence, which was exposed due to the low level of the lake (photo nos. 2 & 3).

All surface erosion should be repaired.

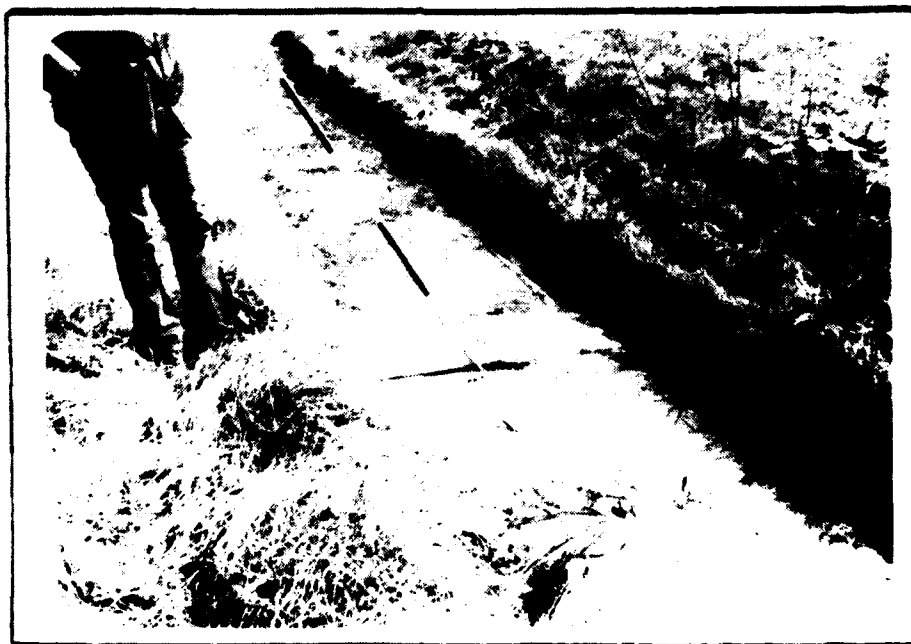
PHOTO NO. 8

Deep holes associated with erosion were also found on the downstream of the crest. The holes appeared to exit on the downstream slope above the upper berm. Fill material was deposited in the concrete drainage channel below (photo no. 8). The deepest hole on the crest was measured to be 8 feet deep vertically (photo no. 6) and appeared to exit from a large hole on the downstream slope (photo no. 7). This hole appeared to be located in line with the drain pipe that extends beneath the dam. There was no evidence to indicate that fill material is entering the pipe. Another large hole is located on the downstream side of the crest near the right end (photo no. 9). The hole is about 3 feet in diameter and several feet deep. It appeared that it is associated with several smaller holes on the downstream slope above the upper berm. Fill material was also observed in the concrete drainage channel in this area.

2. Sloughing, Subsidence, or Depressions; Abnormal
Bulges or Non-Uniformity Several holes exit on
downstream slope. Believed to be associated with
disp. soil. Soil deposited in concrete drainage
channels installed in 1979 to channel surface runoff
and stop erosion.
3. Surface Cracks on Face of Slope None
4. Surface Cracks or Evidence of Heaving at
Embankment Toe None
5. Wet or Saturated Areas or Other Evidence of Seepage
on Face of Slope; Evidence of "Piping" or "Boils"
None
6. Drainage System Operating properly. Flow only from
right drain. Some undercutting of concrete slab
below drains.
7. Fill Contact with Outlet Structure Good condition.
8. Condition of Grass Slope Protection Fair, thin in
some areas.

a. Investigate the cause of the erosive holes on the dam and near the downstream toe of the dam and make recommendations for needed repair. An investigation for the presence of dispersive soils should be included and appropriate recommendations made for treatment if needed.

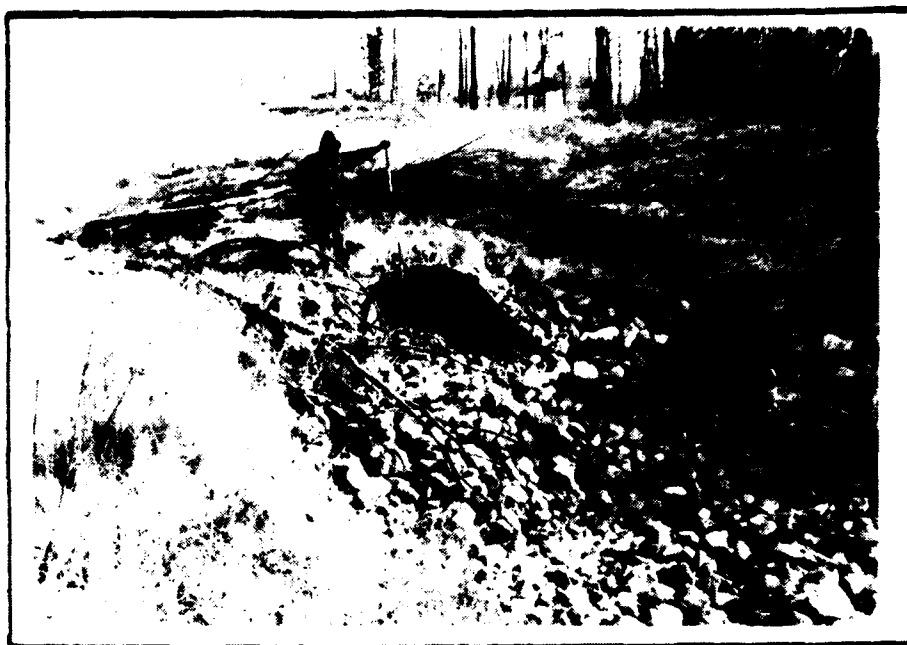
PHOTO NO. 11

3.1.5 Downstream Channel - The downstream channel is variable in width and has almost vertical earth side slopes (photo no. 12). The excavated earth channel below the drain pipe is wet on the side adjacent to the dam and had sloughed (photo no. 13). The opposite side of the channel was dry. Riprap in the impact basin was in good condition (photo no. 11).

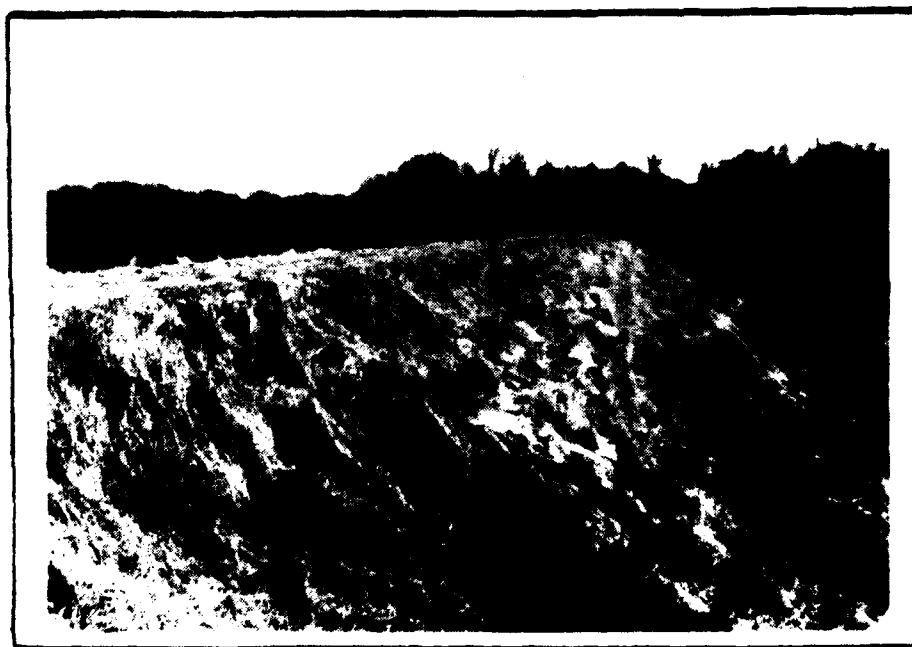
PHOTO NO. 20

- Photo No. 20 - View of the upper portion of the downstream slope where numerous holes associated with erosion of the fill material emerge.
- Photo No. 21 - Overview of the dam and spillway from the left abutment.
